WEICON Applications and Products

MINING, CEMENT & HEAVY MATERIAL HANDLING

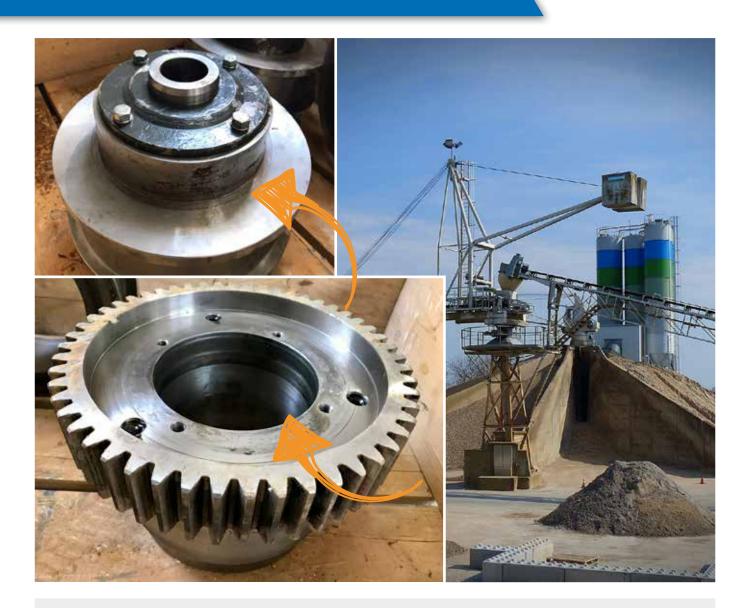
Bonding a wheel and gearwheel in a gravel plant

- ► cleaning with WEICON Surface Cleaner
- high-alloy and hardened steels are bonded with WEICONLOCK AN 306-38 Retaining Cylindrical Assemblies, applied in a curcumferential and fullsurface bead

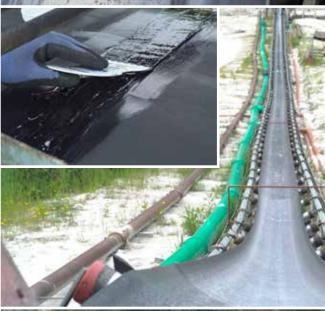
Repair of conveyor belts in a quartz mine

- ► removing coarse dirt
- ► roughening and levelling the damaged areas with an angle grinder (rasp disc or cup wheel)
- ► cleaning the surface with WEICON Cleaner Spray S
- ► mixing and applying WEICON 1K Primer G with a paint brush
- ► allow WEICON 1K Primer G sufficient time to flash off
- ► depending on the container application of WEICON Urethane 85
- ► smoothing the surface with WEICON Contour Spatula Flexy

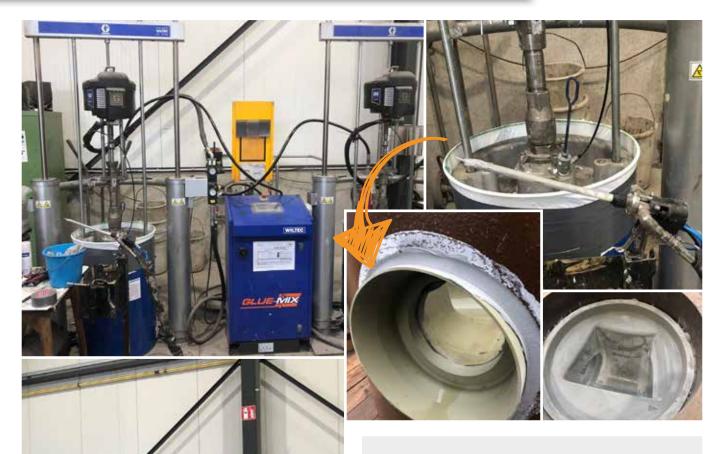
Mounting stoneware sewers with plastic pipes

- ► installation of a dosing system due to the large material consumption
- ► gap-filling and bonding with generous application of WEICON Flex 310 M® 2 K
- ► with this type of drum dosing system, the adhesive is mixedn only in the mixing nozzle

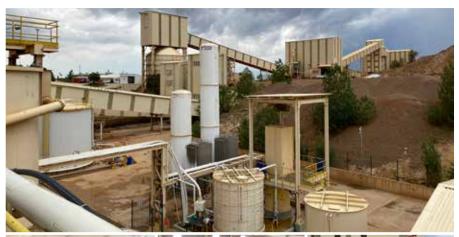
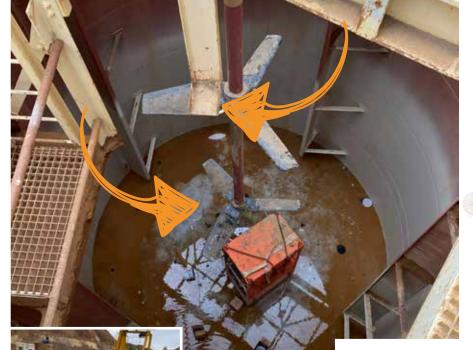
Repair of stirring units in a gold mine

- ► abrasion on stirring units/ propellers caused by sand and stones
- ► sandblasting (SA 21/2) and cleaning with Cleaner Spray S
- ► reconditioning of the propeller blades by coating with WEICON WP
- ▶ 16 kilograms were used

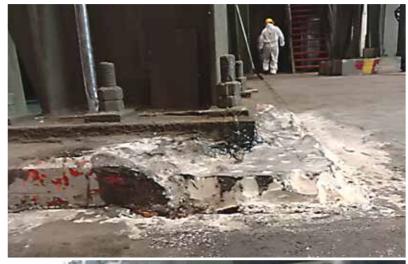
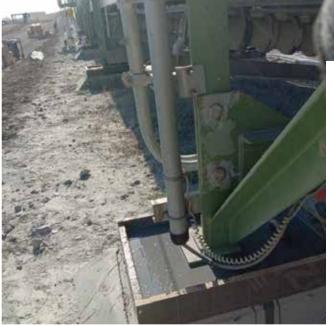
Repairing the foundation of a conveyor system in a copper mine

- ► removing loose foundation parts
- ► creating formwork for the area to be repaired
- ► casting WEICON CBC into the formwork
- ▶ after curing: removing the formwork
- ▶ 1,700 kilograms WEICON CBC were used

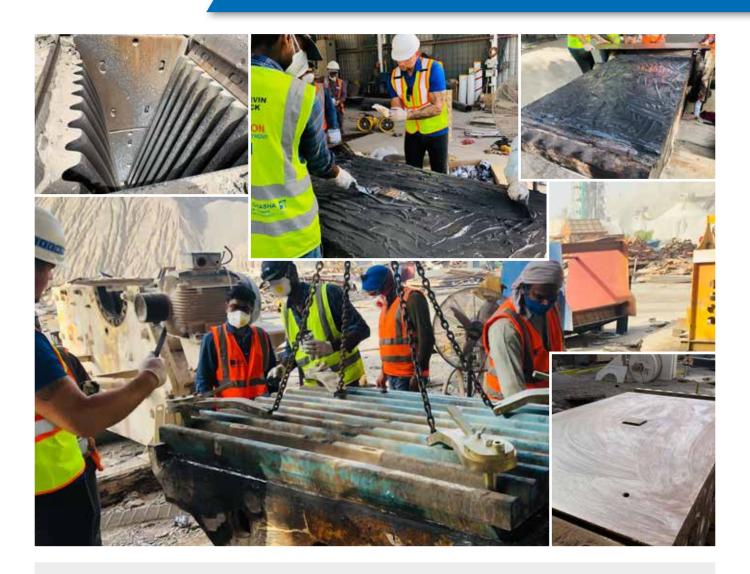
Gap compensation on a press plate in a quarry

- ▶ the support surface of a burst, 400kg heavy press plate did not show 100% force closure anymore
- ▶ previous solution: replacing the press plate every two months
- ► cleaning with WEICON Cleaner S
- ► generous application of WEICON HB 300 to the surface and fixings

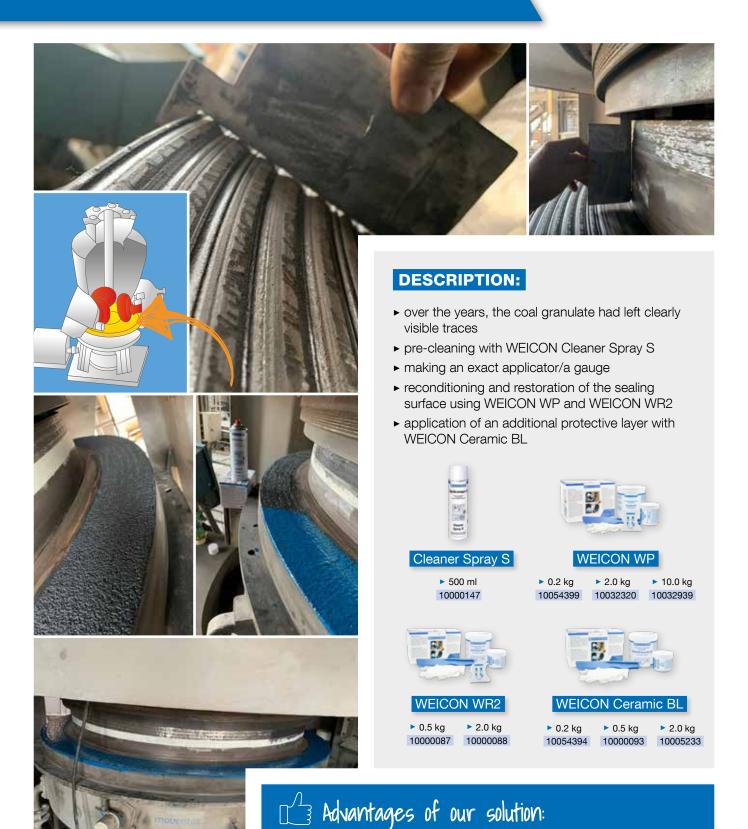
Repair of a coal mill

no welding or exchange of parts necessaryextension of the service life of the coal mill

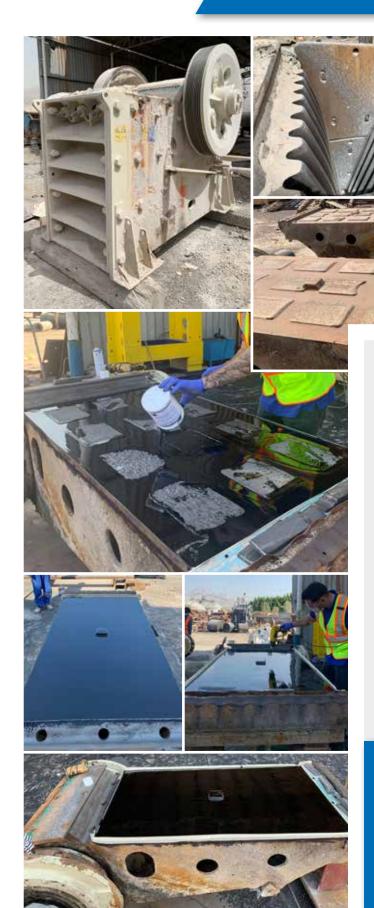
Repair of a stone crusher plate in one of the largest quarries in the world

- ► heavy wear and distortion on the panels due to friction and vibration
- ► cleaning with WEICON Cleaner Spray S
- ► application of 50 kg WEICON WR on one panel
- ► total application of 400 kg WEICON WR on eight stone crusher plates

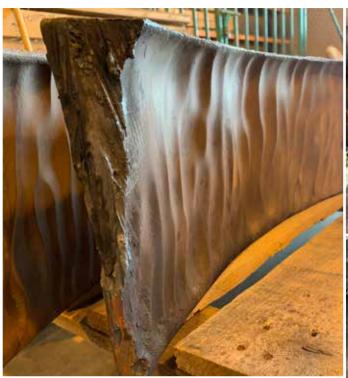
Gap compensation on a crusher in a grinding mill

- ► treatment of the inner ring with WEICON Silicone Spray to enable later disassembly
- ▶ attachment of injection packers with WEICON Easy-Mix PU-90
- ▶ use of WEICON Repair Stick Steel to seal the gap before casting
- ► injection of WEICON WR with the aid of the WEICON Injection Packer Set
- ▶ wear within 4 months, repair 4 times a year, wear from 100 mm to 20 mm
- ▶ approx. 20 kg used for one repair

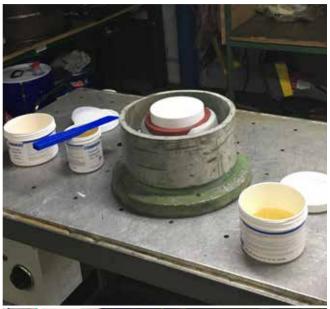
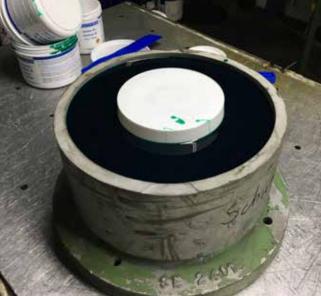
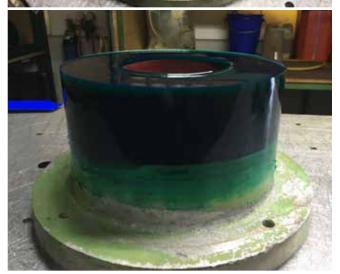
Repair of a flange/sleeve in a gravel plant for fine sand extraction

- ► cleaning with WEICON Cleaner Spray S
- ► sandblasting (SA 2½)
- ► repeated cleaning with WEICON Cleaner Spray S
- ► wetting of the surfaces to be demoulded with WEICON Mould Release Agent liquid
- ▶ approx. 10 minutes flash-off time
- ▶ mixing of WEICON Urethane 80
- ▶ adding WEICON Colour Paste Black as required
- ▶ vacuum suction to avoid air bubbles
- ▶ pouring in the mixed WEICON Urethane 80
- ► heating the casting surface with a hot air gun to avoid air bubbles
- ▶ curing in the oven at approx. 60 °C for 24 hours
- ▶ use of compressed air to facilitate demoulding

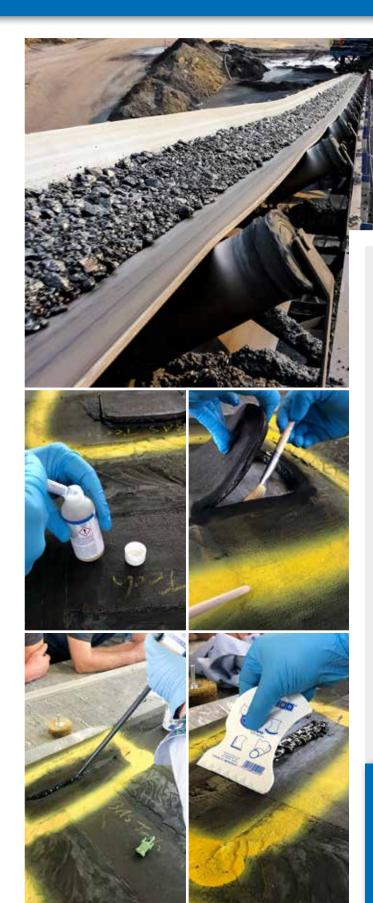
Repair of a conveyor belt

- ► cleaning with WEICON Cleaner Spray S
- ► application of WEICON 1K Primer G for optimum adhesion
- working WEICON Urethane 85 into the rubber surface of the conveyor belt with WEICON Contour Spatula Flexy

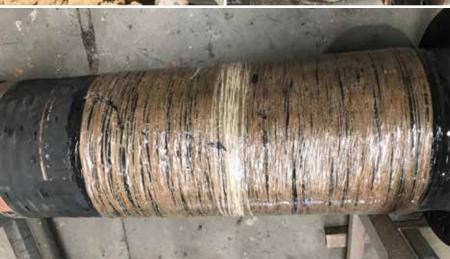
Repair of rubber pipelines in gravel plant

- ► The pumping of sand causes erosion and cracks on the surface of the rubberised joints and connectors
- ► Previous solutions such as hot welding, pouring rubber or attaching patches with glue were insufficient, and consequently the parts had to be purchased anew
- ► Cleaning of larger holes and cracks with WEICON Cleaner Spray S, treatment with WEICON 1K Primer G
- ► Followed by filling with WEICON Urethane 85
- ➤ Outer protective layer with WEICON Urethane 80 and for reinforcement insert with Paracord

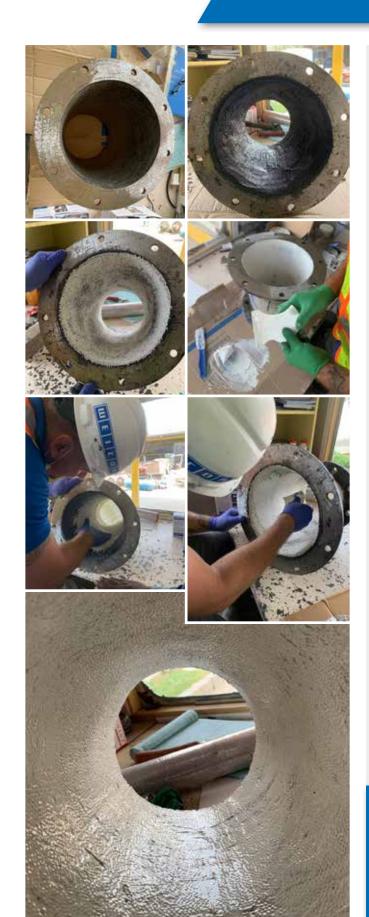
Coating of a cyclone in the mining industry

- ► Mechanical cleaning, substrate pre-treatment, cleaning with WEICON Cleaner Spray S
- ► Application of adhesive layer with WEICON HP
- ► After curing, application of a second coat with WEICON WP
- ► Embedding of 3 mm ceramic balls into the still wet surface
- ► After curing, final sealing with WEICON HP
- ► Abrasion protection coating against limestone particles of 3 to 4 mm in size

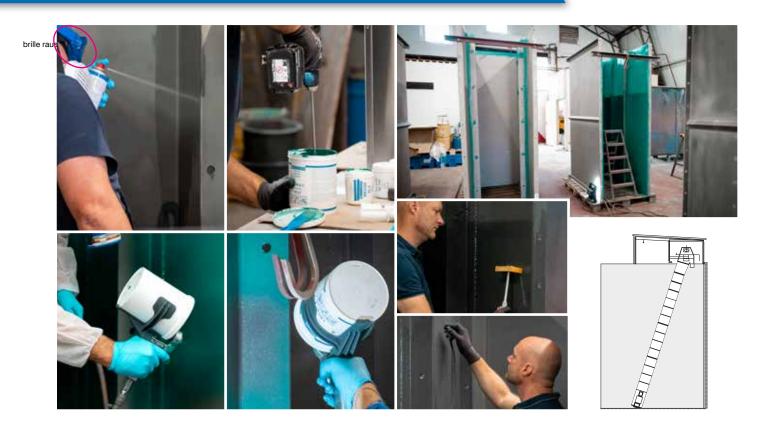
Interior coating of the cladding of a bucket elevator in a salt mine

- ▶ more than 120 m² of steel surface were coated using the spray method with 120 kg of WEICON GL-S and WEICON Ceramic HC 220
- ▶ in the bucket elevator, salt is transported upwards over six levels
- ▶ the interior of the bucket elevator is lined with steel sheets, which had been corroded by salt dust due to a simple paint coating inside
- ► cleaning with WEICON Cleaner Spray S after sandblasting
- ▶ the resin component was heated to approx. 50 °C before mixing
- ▶ application of a layer of WEICON GL-S
- ▶ application of a layer of WEICON Ceramic HC 220
- ▶ search for possible defects, followed by inspection of the layer thickness

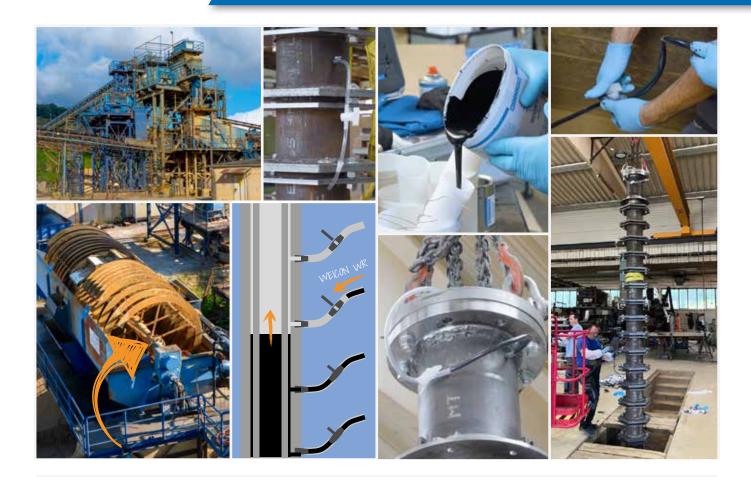
Filling the gap on a rotor shaft in a gravel washing plant

- ► a 4 mm gap between the inner and outer shaft needed to be filled with WEICON WR, without air inclusions, to increase the shaft stability
- ➤ at intervals of one metre, threaded holes towards the gap were drilled in order to attach a hose with valve to them
- ► WEICON WR was pressed through the hose into the gap, until the top drill hole was reached
- ▶ after 24 hours, WEICON WR had completely cured

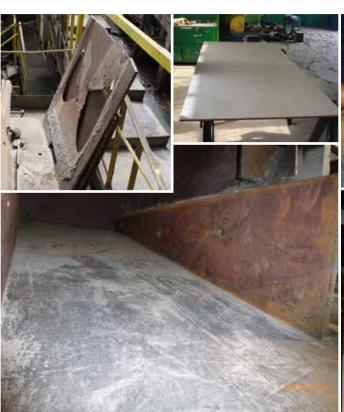
Maintenance work on the outlet base plate of a hopper in a mine

- ► sandblasting, then removal of sandblasting residues (dust)
- ► cleaning the surface (using WEICON Cleaner S, WEICON Surface Cleaner)
- ▶ application of wear protection WEICON WP
- ▶ use of PE foil to compress and smooth out the surface

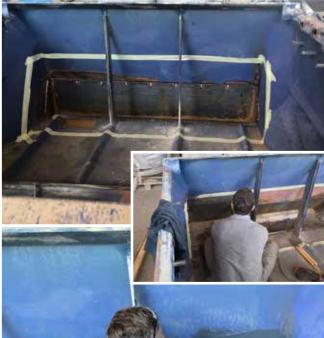
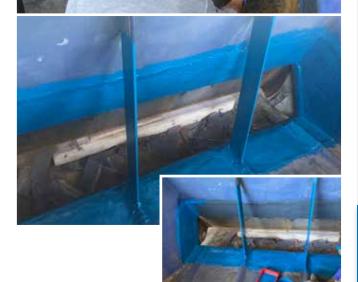
Repair/coating of a gravel hopper in a concrete plant

- ► A heavily used bucket needed repairing
- ► Many years ago, the bucket was equipped with PU wear protection mats all around
- ➤ Over time, the mats have loosened, sand moisture and grit have infiltrated the mats and loosened them from the material support
- ▶ Preparation: Area calculation approx. 11.22 cm³ / approx. 1.4 m², marking, removal of damaged material
- ► Pre-treatment of the substrate: rust removal with Bristle Blaster, then cleaning with WEICON Industrial Cleaner
- ► Final cleaning with WEICON Industrial Cleaner
- ► Application of WEICON WR2 over a wide area
- ► After the drying phase, coating with WEICON Ceramic BL

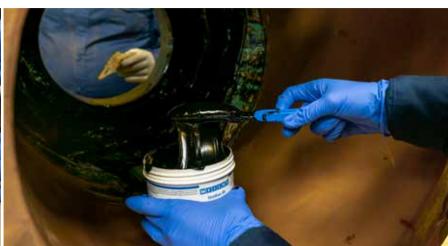
Repair of a centrifugal separator in a concrete plant

- ▶ the polyurethane coating of the centrifugal separator had been damaged over time by conveying gravel and sand
- ► cleaning with WEICON Cleaner S
- ► application of WEICON 1K Primer G and flash-off time of approx. 30 minutes
- ➤ mixing of WEICON Urethane 85 resin and hardener thoroughly without air bubbles
- ▶ filling the damaged areas with WEICON Urethane 85
- ► application of WEICON Urethane 85 with WEICON Contour Spatula Flexy and paint brush and subsequent smoothing out

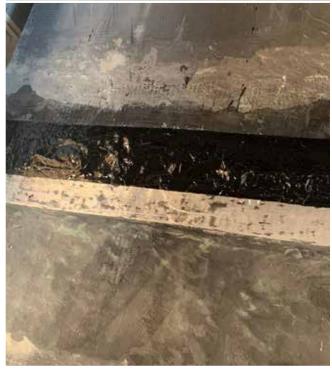
Repair of a damaged area on the conveyor belt of a bucket elevator in the cement industry

- ▶ removing coarse rubber residues from the damaged area
- ▶ roughening the repair area with abrasive cloth
- ► cleaning with WEICON Cleaner Spray S
- ▶ application of WEICON 1K Primer G
- ▶ application of WEICON Urethane 85

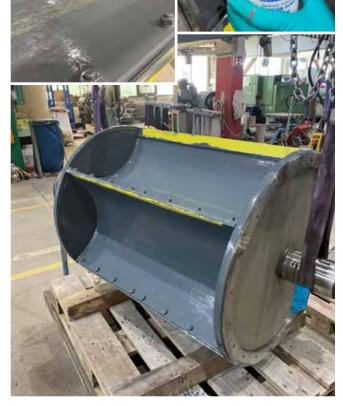
Coating of rotary valve in a cement plant

- ► a mineral material is conveyed, which causes strong adhesion to the rotary valve and the scraper
- ▶ the stainless steel components (approx. 3.5 m²) were sandblasted, heated with a fan heater and then coated with a 2-layer system of WEICON Anti-Stick
- ► the use of WEICON Anti-Stick is intended to extend the service life

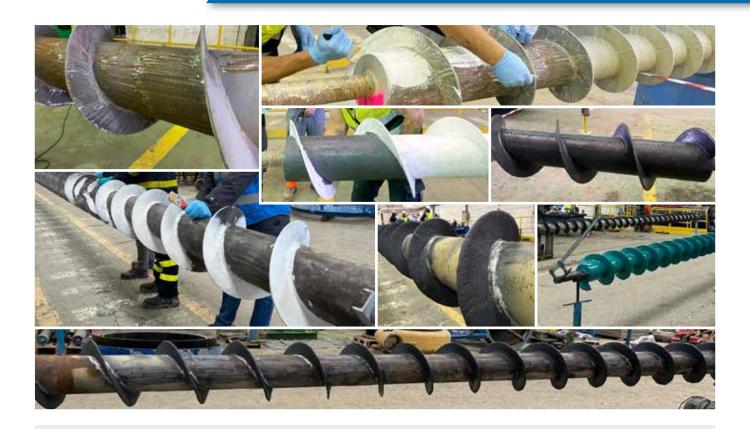
Repair and protection of a screw conveyor in a copper mine

- ▶ in copper mines, screw conveyors are used to transport ores and other materials. Particularly useful when the materials are fine-grained, powdery or loose. These materials are highly corrosive
- ▶ due to abrasion and wear, the blades lost up to 20 mm of metal
- ► the surface was roughened with a grinder to remove the protective paint and roughen the surface
- ▶ first, a layer of WEICON HP was applied as a primer
- ▶ then, a layer of WEICON WP was added "wet-on-wet" and compacted to make the surface as smooth as possible
- ➤ as a surface finish for visual inspection WEICON GL-S was added on one of the screws
